LAUDA Service-Info ECO cooling thermostats

Warning 044 – ‘Chiller missing’

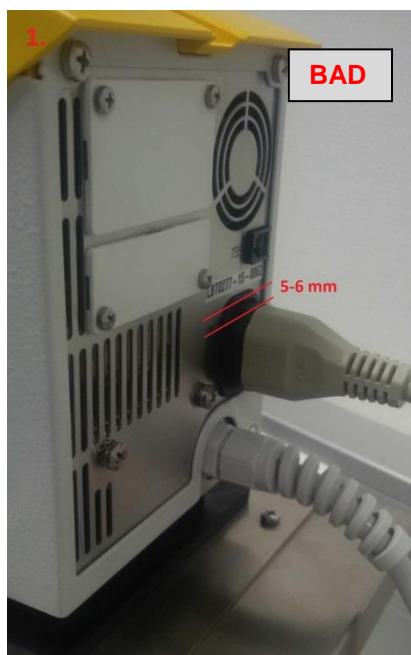
Problem: Missing cable connection between device underpart and control head or bad connection due to not fully inserted plug into socket 51H.

Solution: Check if the plug of the connection is inserted properly.
Please follow the next step if it looks like on picture 1:

Switch off device and push the plug with some more force whilst counter with the other hand at the front panel. Switch on the device again.
